The Northwest Tropical Atlantic Station (NTAS): NTAS-2 Mooring Turnaround Cruise Report

Technical Report

WHOI-2002-07 UOP-2002-04

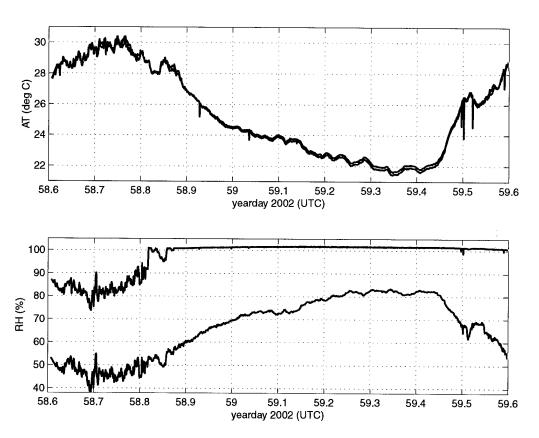
Continued testing, confirmation of the calibration constants, and comparison with hand-held sensors, led to the conclusion that the RH sensors of both HRH 225 and 227 were malfunctioning (AT performance was good). Visual inspection showed no obvious problems, and attempts to improve performance (e.g. by "drying out" the electronics with desiccant) were unsuccessful. It was decided that it would be necessary to recover the "good" HRH module from the NTAS-1 buoy (at sea), swap the flash card and EPROM with one of the "bad" NTAS-2 modules, and mount the refurbished NTAS-1 module on the NTAS-2 buoy.

Figure 13. Comparison of HRH SN 225 (red) and SN 226 (blue) during pre-cruise testing in Barbados. The AT sensors performed as expected, but SN 225 RH was about 30% higher than SN 226, and showed "saturation" when SN 226 was above about 60%.

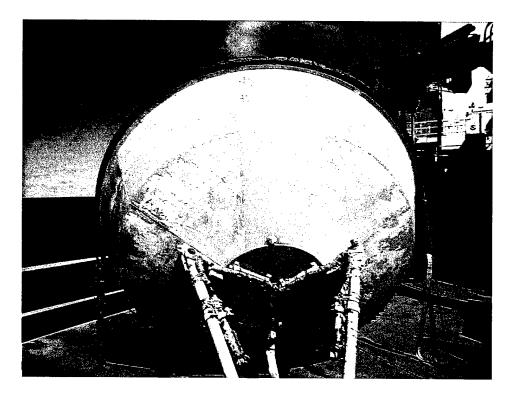
Figure 34. NTAS-1 discus buoy hull after recovery.

Fouling to protected regions of the buoy was localized on the bottom of the hull near where the bridle legs attach (Figure 35). The few gooseneck barnacles visible above were the only hard fouling organisms observed on the hull. Because these barnacles are clustered in protected regions of the hull, we assume that biological means of fouling control are keeping fouling in check where the antifouling paint has eroded away.

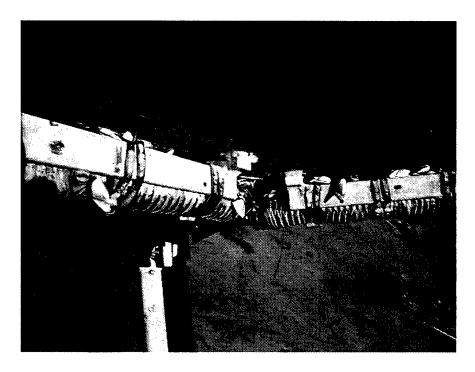
Figure 35. Gooseneck barnacle fouling on the NTAS-1 buoy hull.

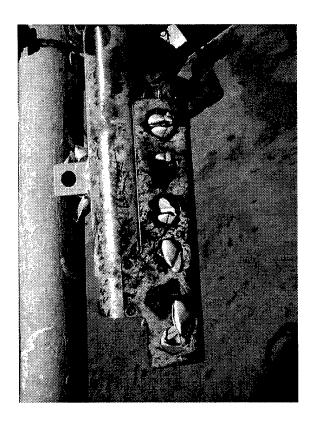
Most of the fouling observed was on instrumentation positioned near the surface. The SBE-37 MicroCATs attached to the bridle legs of the buoys at 2.1 m were the most heavily fouled instruments, especially around the sensor region of the instrument. Gooseneck barnacle fouling inside the guard that protects the sensor of the MicroCAT is visible in Figure 37. It is possible that this fouling caused one of the two MicroCAT instruments to give false temperature measurement due to the restriction of flow around the sensor.

Figure 37. Gooseneck barnacle fouling of MicroCAT sensor area.
